Home Report

Mathas Cottage

Single Survey and Mortgage Valuation Report

Property address	Mathas Cottage, Ellon, AB41 8QX
-------------------------	---------------------------------------

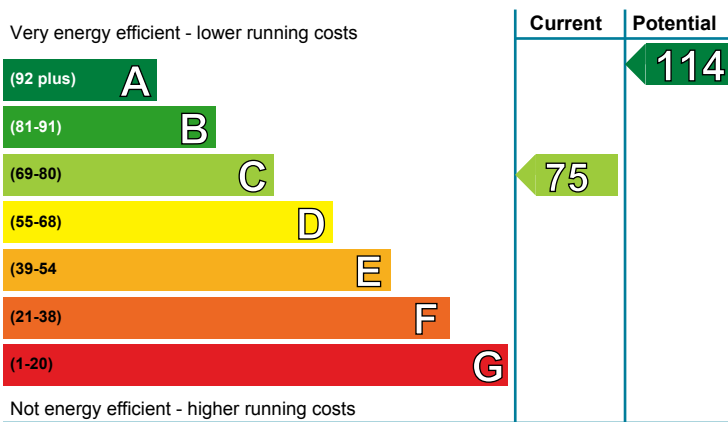
Energy Efficiency Rating

This graph shows the current efficiency of your home, taking into account both energy efficiency and fuel costs. The higher this rating, the lower your fuel bills are likely to be.

Your current rating is **band C (75)**. The average rating for EPCs in Scotland is **band D (61)**.

The potential rating shows the effect of undertaking all of the improvement measures listed within your recommendations report.

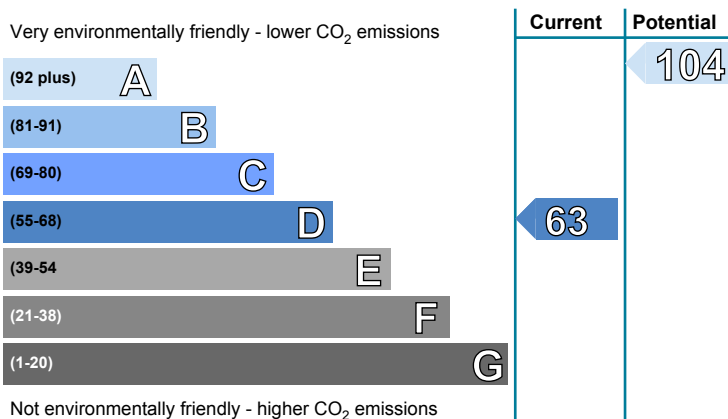
Environmental Impact (CO₂) Rating

This graph shows the effect of your home on the environment in terms of carbon dioxide (CO₂) emissions. The higher the rating, the less impact it has on the environment.
