HOME REPORT

Energy Performance Certificate (EPC)

BANKHEAD HOUSE, AUCHTERLESS, TURRIFF, AB53 8BD

Single Survey

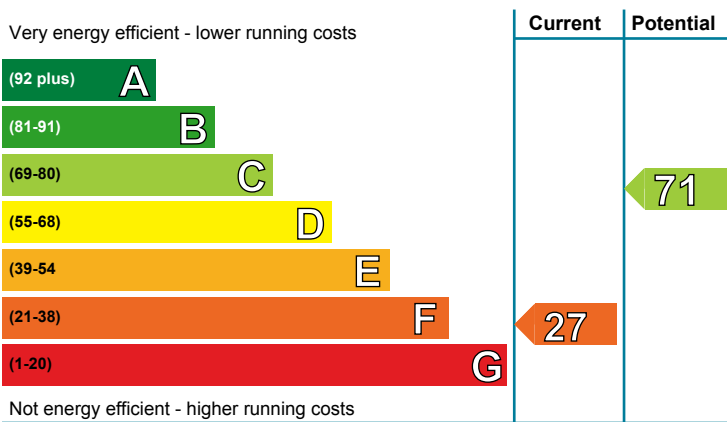
Energy Efficiency Rating

This graph shows the current efficiency of your home, taking into account both energy efficiency and fuel costs. The higher this rating, the lower your fuel bills are likely to be.

Your current rating is **band F (27)**. The average rating for EPCs in Scotland is **band D (61)**.

The potential rating shows the effect of undertaking all of the improvement measures listed within your recommendations report.

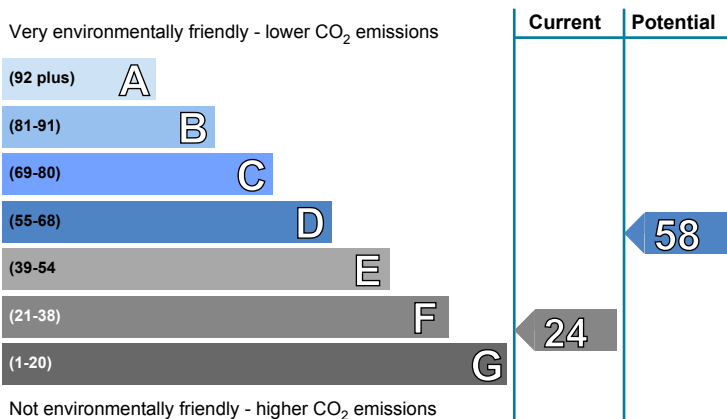
Environmental Impact (CO₂) Rating

This graph shows the effect of your home on the environment in terms of carbon dioxide (CO₂) emissions. The higher the rating, the less impact it has on the environment.

Your current rating is **band F (24)**. The average rating for EPCs in Scotland is **band D (59)**.

The potential rating shows the effect of undertaking all of the improvement measures listed within your recommendations report.
