Home Report

Single Survey and Mortgage Valuation Report

Property address	Cauldcots, Fettercairn, Laurencekirk, AB30 1DR
-------------------------	---

Prepared by	Allied Surveyors Scotland Ltd
--------------------	-------------------------------

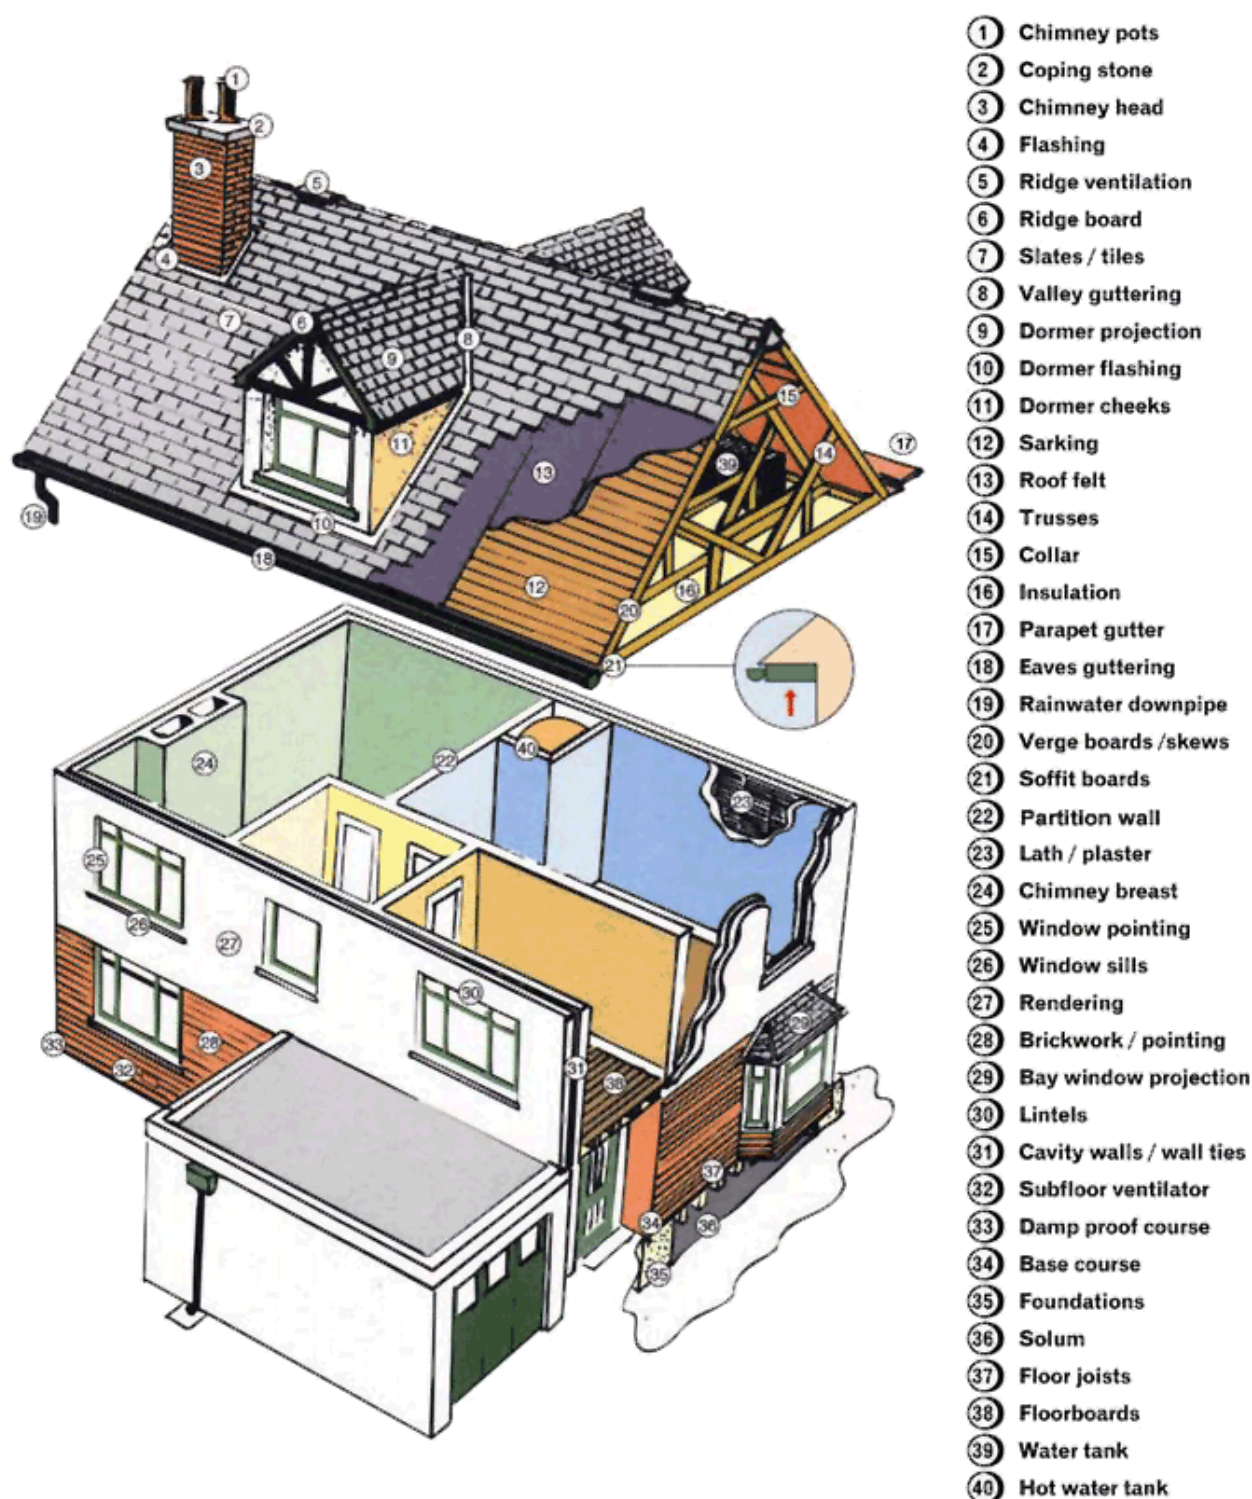
Sectional Diagram showing elements of a typical house

Reference may be made in this report to some or all of the above component parts of the property. This diagram may assist you in locating and understanding these items.
