Single Survey

survey report on:

Property address	Lower Blackburn, Dunlugas, Turriff, AB53 4NS
-------------------------	---

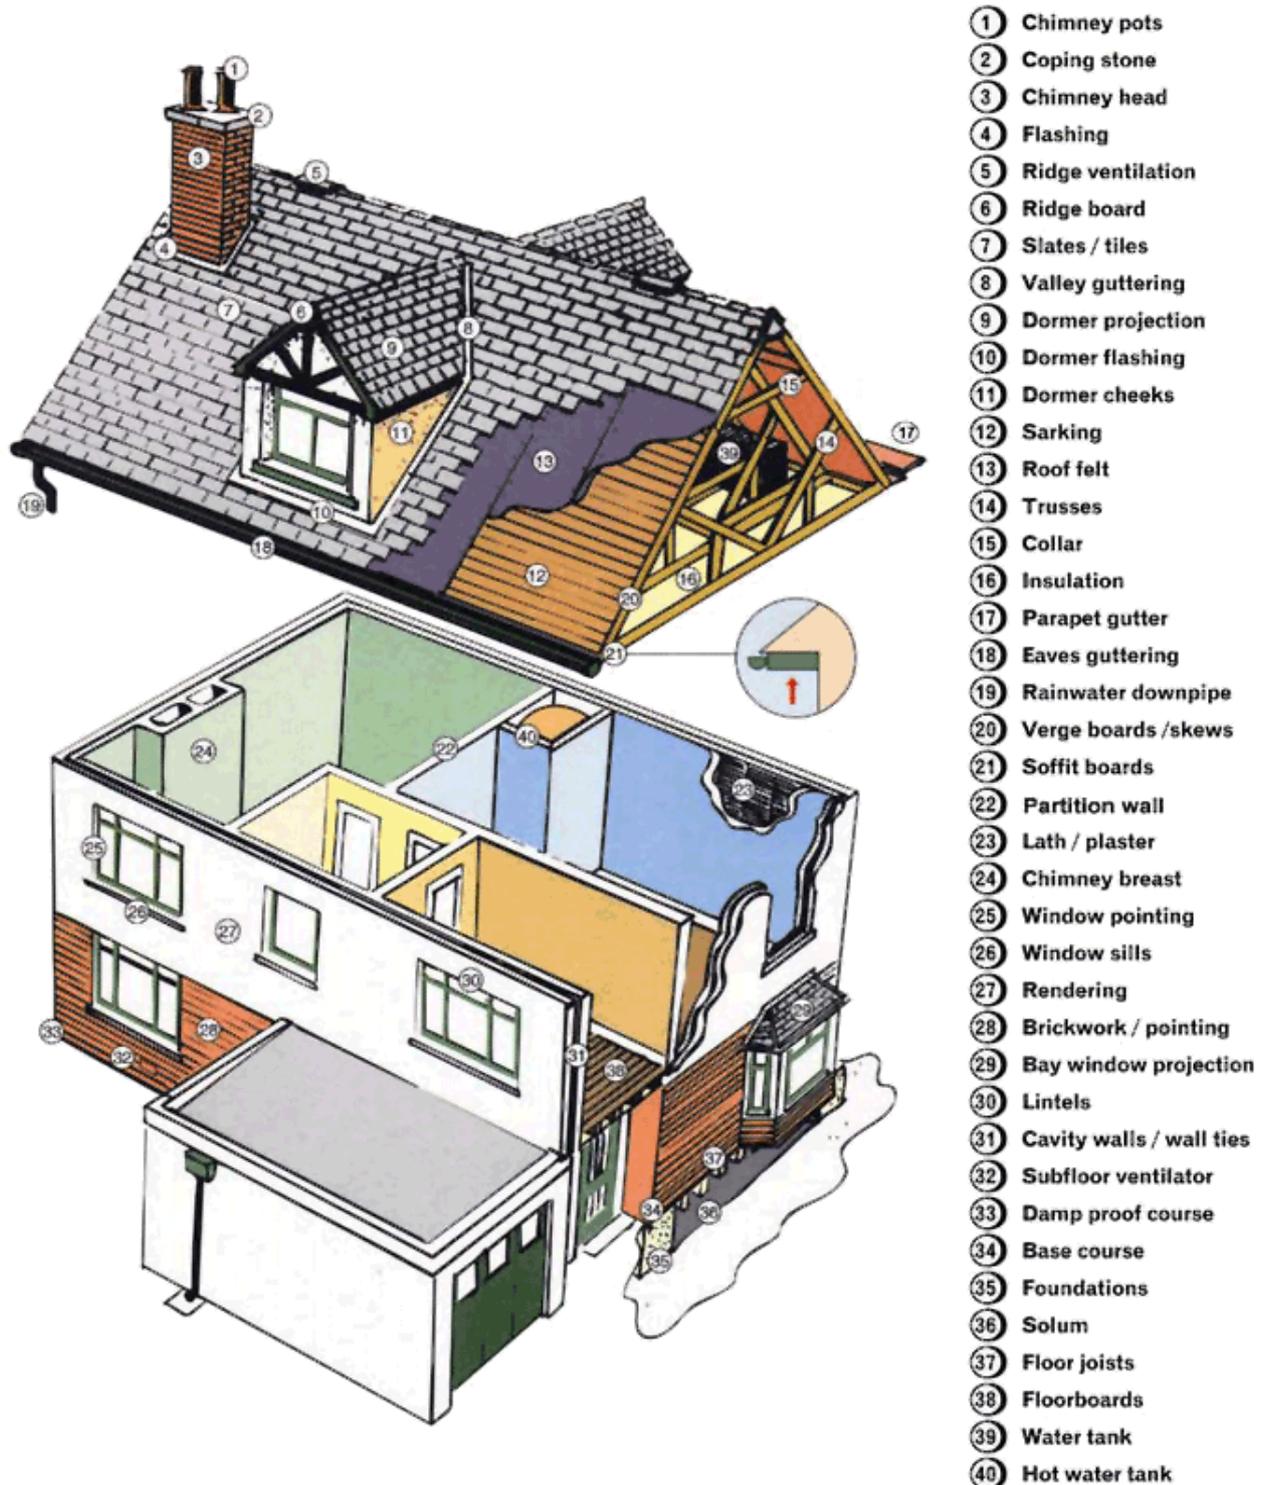
Sectional Diagram showing elements of a typical house

Reference may be made in this report to some or all of the above component parts of the property. This diagram may assist you in locating and understanding these items.
